CHARBOSS PROTOTYPE AIR CURTAIN INCINERATOR PILOT TESTING

COMPLIANCE MONITORING & RECORDKEEPING REPORT

IN ACCORDANCE WITH MUTUAL AGREEMENT AND FINAL
ORDER NO. AQ/ACPD-ER-2020-18

USDA Forest Service
Pacific Northwest Region
1220 SW Third Avenue
Portland, OR 97204

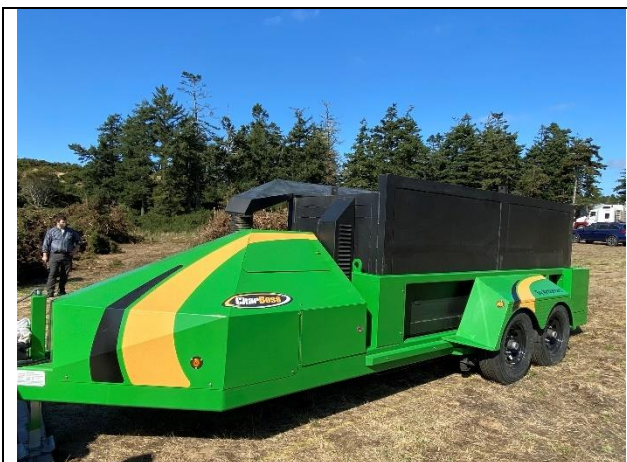
Figure 1 ABI CharBoss.

The CharBoss is a prototype air curtain incinerator (ACI) under development through a Cooperative Research and Development Agreement (CRADA) between the FS and Air Burners, Inc (ABI), of Palm City, Florida. The CharBoss is an ABI Burn Boss Model T-24 which has been modified to recover biochar. The CharBoss was developed to provide a clean burning alternative to open burning small slash piles. The CharBoss is a BurnBoss with the addition of a moving grate in the bottom which removes the char during operation. A small quantity of ash accumulates beneath the prototype machine. Char is discharged by a mesh conveyor to a water quench tank. Wet char was extracted from the tank. The operation of this prototype was guided by the temperature at a thermocouple below the grate. Operation within temperatures which would not damage equipment provided a consistently clean operation. Figure 1 and 2 are pictures of the CharBoss.

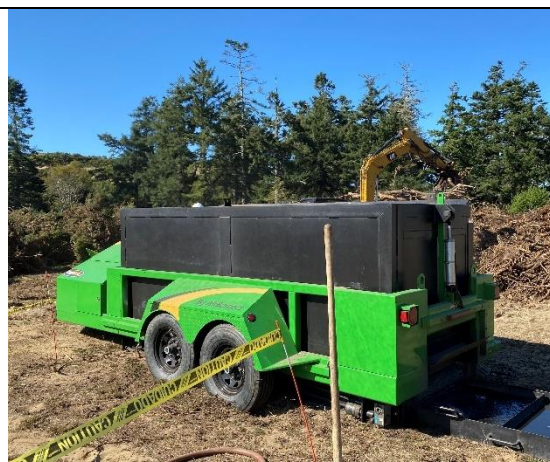
Figure 2. Setup with Biochar Discharge in lower right.

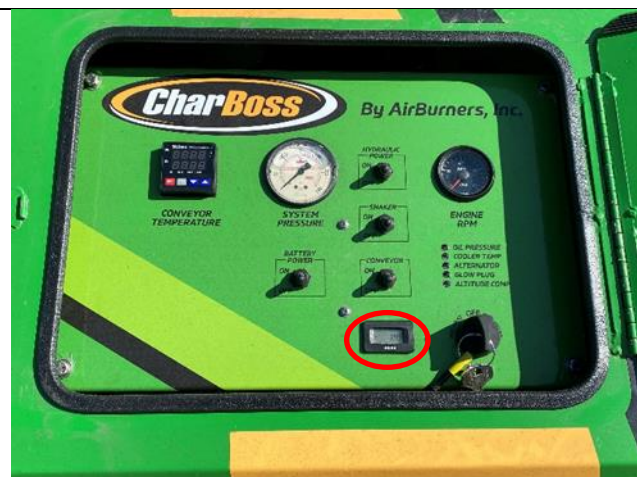
Figure 3 CharBoss Control with Hour Meter (noted by the red oval)

Figure 3 is a photograph of the elapsed timer on the CharBoss which was required under Paragraph B.3 of the MAO.

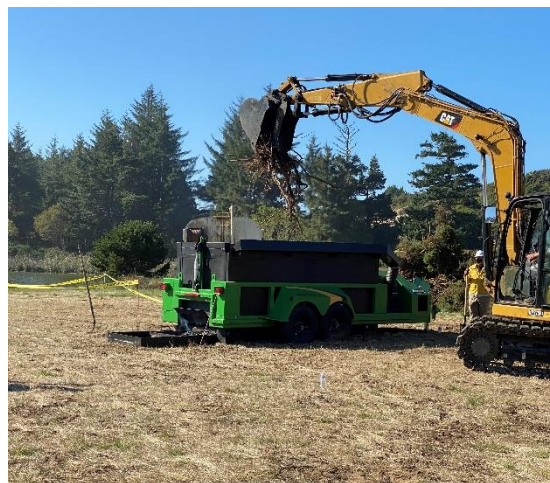
Figure 4. Loading the CharBoss

Figure 4 is a photograph of the CharBoss being loaded.

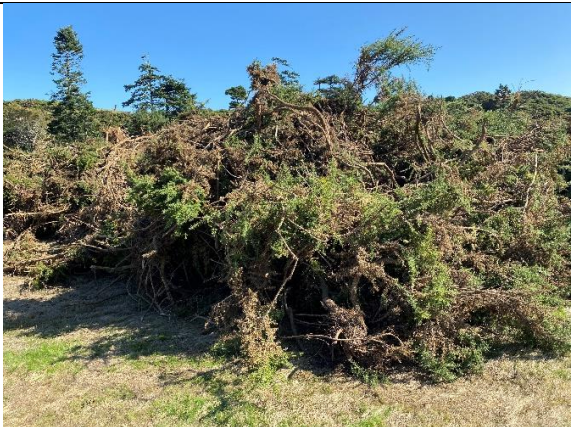
Figure 7 Green Gorse Pile

Gorse (*Ulex europeaus*) is an invasive species which can be transported and is normally open burned in place to destroy volunteer seeds. Figures 7 and 8 are photographs of green and dry Gorse, respectively. Gorse has become very prolific throughout Bandon. Approximately 35,000 acres of Gorse surround the city and have twice caused the city to burn. Testing at the Bandon site is part of an effort to explore ways to utilize this material.

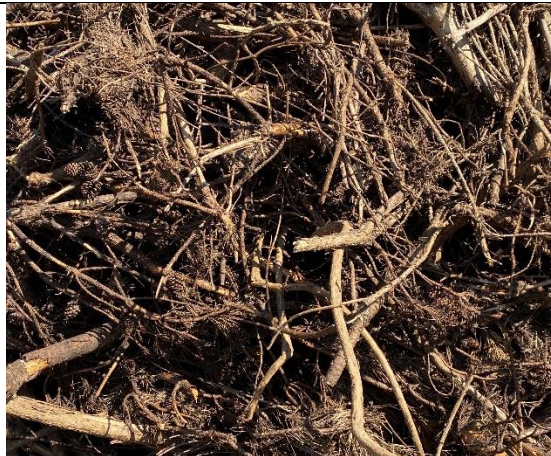
Figure 8. Dry Gorse Pile (close up)

The Bandon Dunes Resort prepared piles of Gorse for testing. Fuels were identified and sampled by USFS personnel. Gorse at Bandon is “plucked” from the soil and is not contaminated. The Gorse contained sand or dirt which the loader shook off the fuel prior to loading. The sand in the dry Gorse is screened from the char by the machine and is reflected in the weight of the ash in

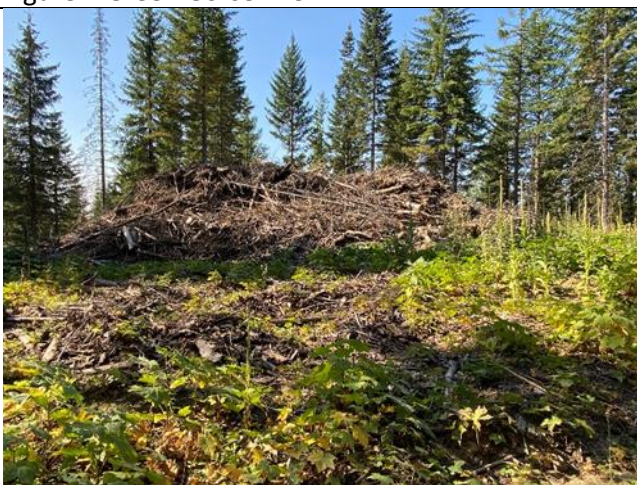
Figure 9. Feedstock pile of White Fir at Tollgate

White Fir (*Abies concolor*) slash was the material used in the testing at the Tollgate site on the Umatilla National Forest. The slash resulted from thinning to reduce hazardous fuels and improve forest health. The slash is composed of solid wood, branches and needles and is usually burned in open piles. The slash had been piled alongside a logging road during thinning and was left for testing as shown in Figure 9. Figure 10 is a close up view of the White Fir feedstock. Forest slash at Tollgate was piled during harvest and had little or no rocks, dirt or other non-wood components. The slash pile was inspected by USFS personnel prior to the burn to ensure only clean wood was used.

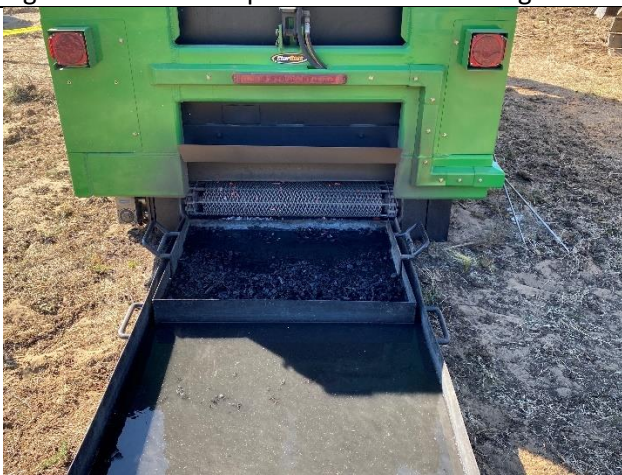
Figure 11. Biochar Discharge to Water Bath

Figures 11-14 are photographs showing the biochar being produced from CharBoss. The discussion of the biochar production rate is presented later in this report, under the Air Toxics section.

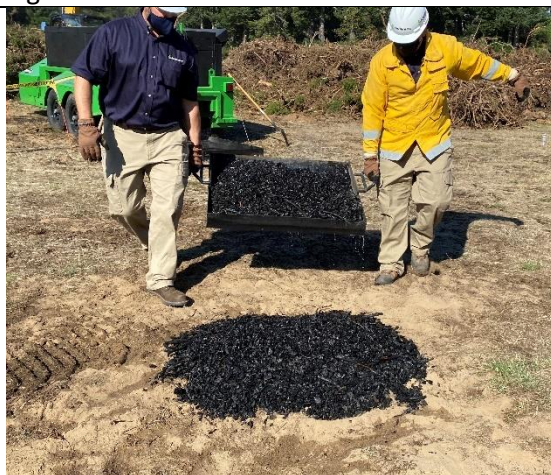
Figure 12. Unloading Biochar

biochar, ash, and the water used for quenching the char. The mass of the biochar was determined by measuring the volume of material produced in five-gallon buckets and applying the bulk density of biochar (dry weight). The mass of the ash was determined by measuring the dimensions of the ash pile remaining after the CharBoss was moved (see Figure 15). The pile volume was converted to dry mass using the average of the four laboratory measurements of the four-corners of the ash pile at each site. Any metals which remained in the quench water would adhere to any solids in the water. The percent of solids in the quench water was measured in the laboratory, and that value was converted to dry mass. The table below presents the input values and bulk density values needed to determine the mass of three output streams: biochar, ash, and quench water.

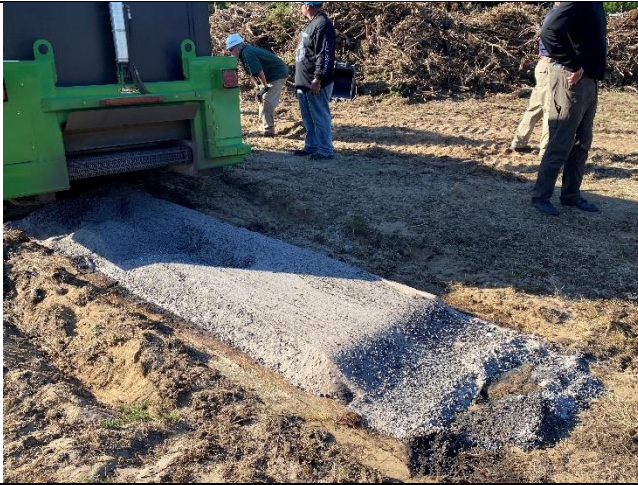
Figure 15. Ash pile under the CharBoss.

*Ash at Bandon site was denser than that at the Tollgate site. This is because the ash at the Bandon site contained sand which sifted through the screen inside the CharBoss. The ash at Tollgate was much lighter because it didn't contain sand.
